**FIRST FIVE-YEAR REVIEW REPORT FOR
NORTH RIDGE ESTATES SUPERFUND SITE
KLAMATH COUNTY, OREGON**

JUNE 2021

**U.S. Environmental Protection Agency
Region 10
Seattle, Washington**

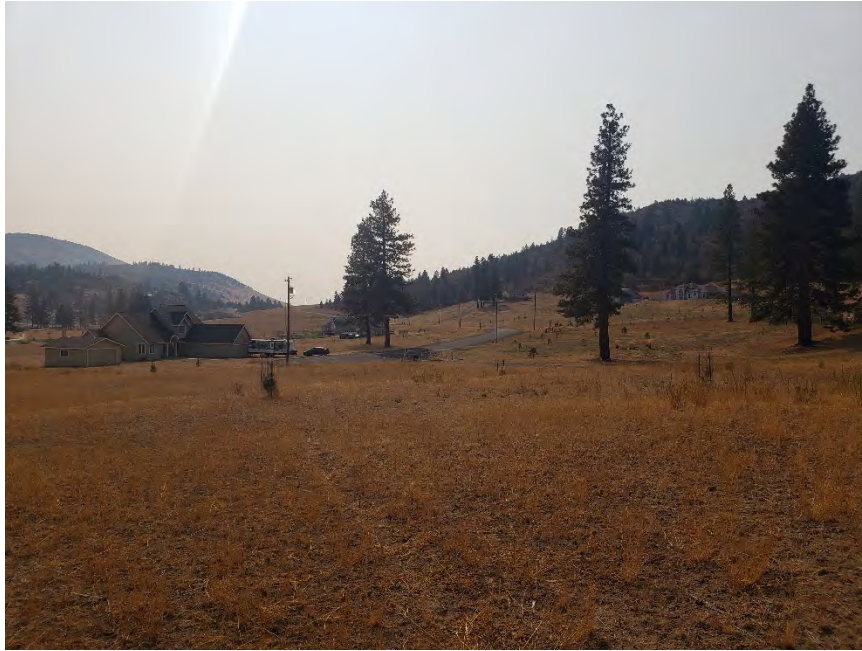
Photo of the Site from Parcel H facing south

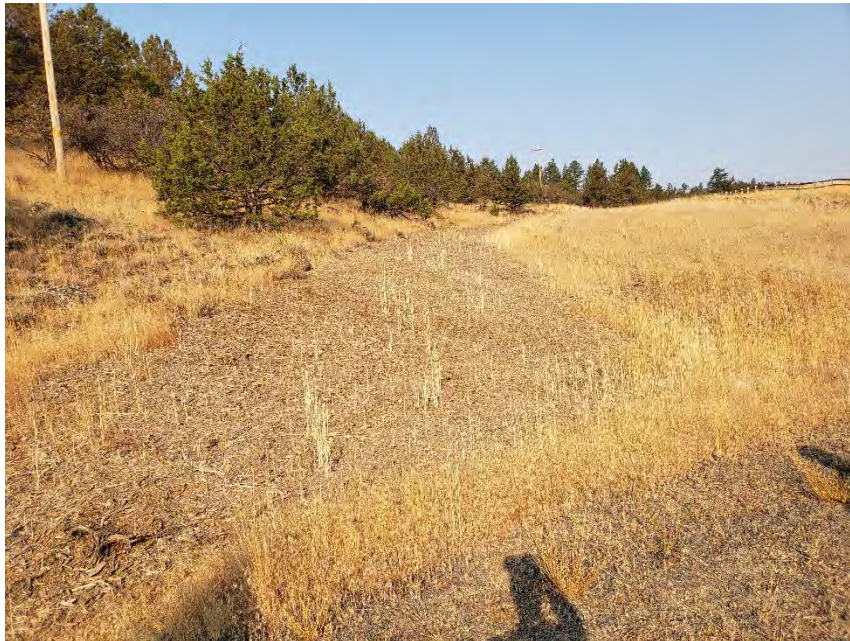
- Swimming Pool Repository (Parcels AG, MBK-E, AL, AI, BL and Y) - Several rills and a rill that transitions to a gully were noted on the slope of the repository.

Swimming Pool Repository mulch area

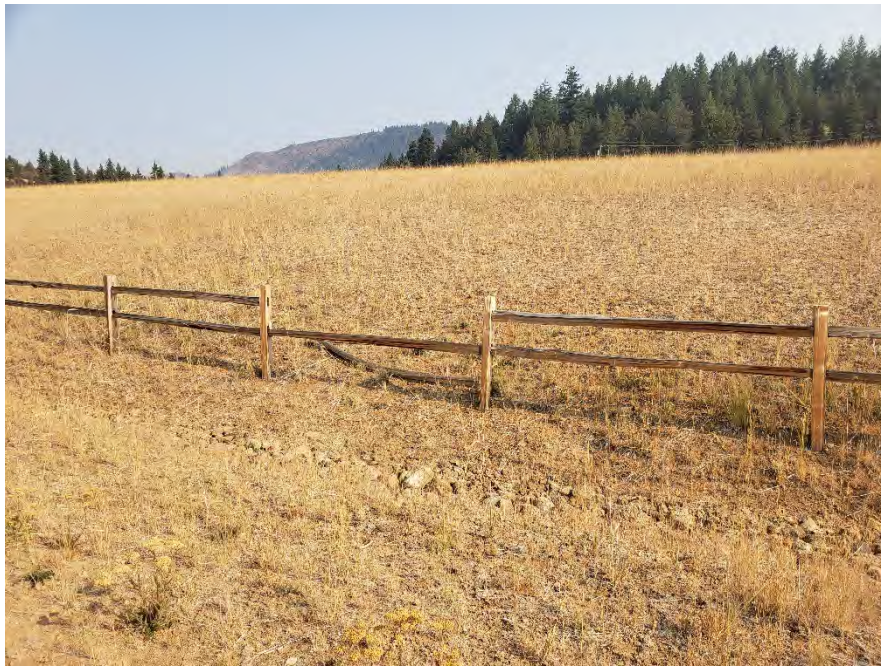
EPA also noted part of Parcel AG, located within the Memorial Park, where vegetation has not become established. Vegetative growth is also impeded above the Memorial Park Repository, where surplus woodchips from remedial construction were distributed. Vegetation is an important element of the remedy and is needed to prevent erosion of the cap.

Memorial Park fence

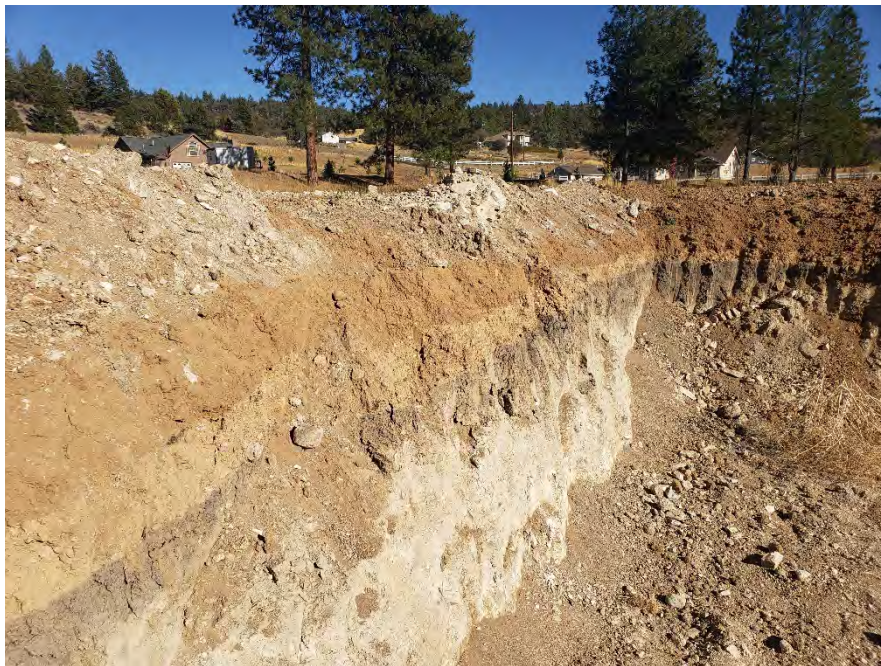
One major finding was the violation of institutional controls on Parcel O, where the property owner excavated greater than 2 feet below ground surface to construct a pond. ODEQ and the property owner determined that the violation resulted from a misunderstanding about the notification process property owners must follow before

digging under the protective cap (greater than 2 feet below ground surface); see Appendix H – Supporting Documentation. The ODEQ, with input from EPA, has now developed a new informational fact sheet for site residents (Appendix K). Further resolution of the Parcel O violation is pending as of the time of this review.

Violation of property institutional controls at Parcel O

- On-site excavation on Parcel O by the current resident suggests potential issues with the institutional controls and excavation approval requirements. However, this violation was promptly reported to the state and the property owner partially followed the excavation and notification requirements; this indicates that this violation likely resulted from the resident misinterpreting the requirements rather than intentional violation. To address this in the future, the state has developed an information fact sheet to distribute among residents to better clarify institutional control requirements. EPA has reviewed and provided approval of the draft fact sheet as of October 2020. The final fact sheet is attached as Appendix K.
